**Flood Control Project Maintenance
Levee Inspections**

Fall 2019 Levee Maintenance Deficiency Summary Report

**Flood Control Project Maintenance
Levee Inspections****LMA District Cover Sheet****Fall 2019 Levee Inspection Results****Sutter Maintenance Yard Tisdale Bypass**

Sutter Maintenance Yard Tisdale Bypass

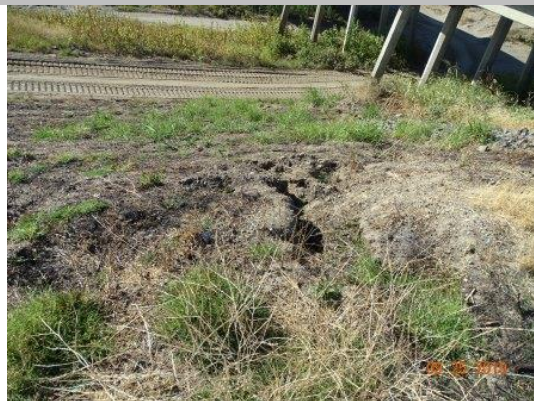
Photo 1 of 1 : FA_2019_ST0009_286_13_20190926_00020.jpg

View of the erosion along the waterside slope. Fall 2019.

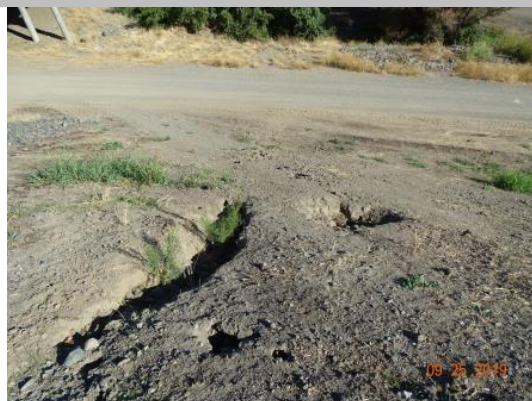
Photo 1 of 1 : FA_2019_ST0009_286_9_20190926_00021.jpg

View of the erosion along the landside slope. Fall 2019.

| E2 : Schedule repair of erosion site prior to the next inspection. | | | | | |

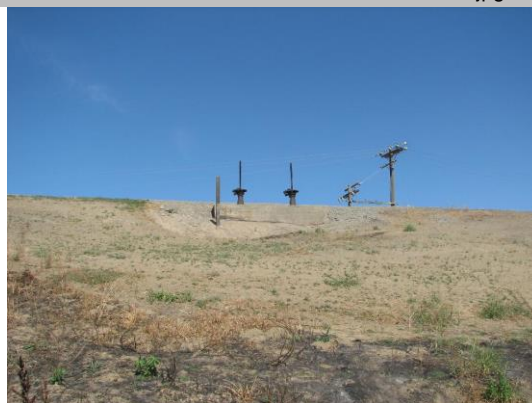
Photo 1 of 3 : UCIP_FA_2019_51484_64226.jpg

| DS_ID:16591 FS_ID:51484 EP_NO: 10099 Repair Type: No Action Needed Crossing Status: Found UCIP Comments: 4/10/2017 Crossing appears to be in good condition. (DWR Sutter Yard- A Freitag)10/11/2016 Crossing appears to be in good conditon.(DWR Sutter Yard - a Freitag)4/18/2016 Crossing appears to be in good condition. No noticeable issues to report.5/7/2015 Crossing is in good condition. No noticeable issues to report.11/13/2014 Same as last inspection.5/12/2014 Same as last inspection.10/30/2013 Same as last inspection.5/20/2013 Same as last inspection. FIELD_STRUCT_DESC: 1 of 2: 4-foot by 7-foot reinforced concrete discharge tunnel through the levee, 38 feet below the crown. Slide gate in 4-foot by 15-foot concrete well on the waterside (WS) slope. Pump house located on the landside (LS) toe and wooden flap gates on the WS toe. (two 4-foot by 7-foot tunnel [HLM 2.13] authorized under Automatic Board Order (ABO) issued as Permit No. 10099, 1955 - Reclamation District No. 1660). [Additional Reference(s): DWR Levee Log, 1993. USACE Sacramento O&M Manual 133, August 1955 (Station 1044+60)]. FS Date: 4/12/2017 9:20:05 AM | | | | | | |

Slide gates on WS shoulder.

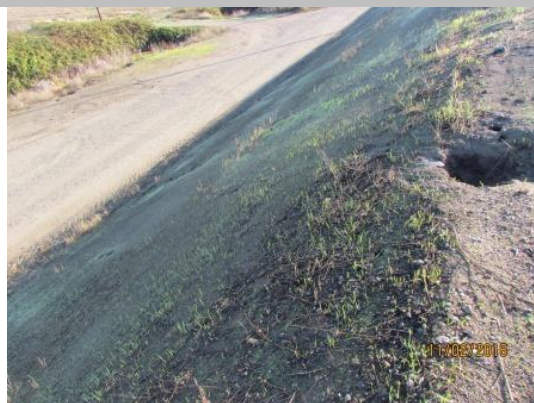
Photo 2 of 2 : FA_2019_ST0009_286_12_20190822_00003.jpg

Another view of the rodent holes along the crown and landside slope.

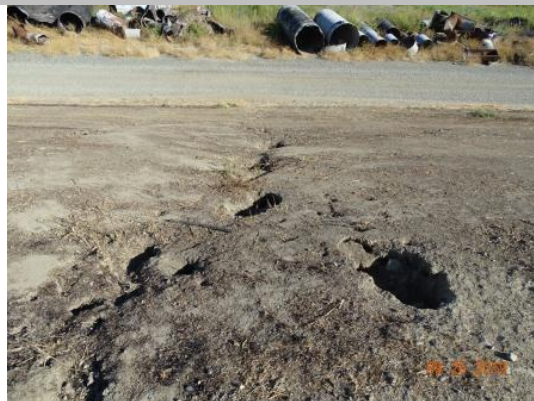
Photo 1 of 1 : FA_2019_ST0009_286_14_20190926_00022.jpg

View of large animal burrows on the landside slope. Fall 2019.

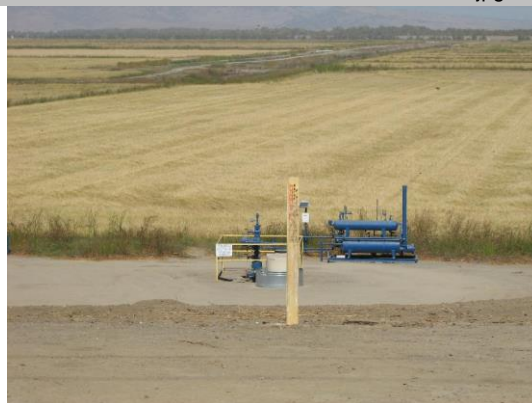
Photo 2 of 2 : UCIP_FA_2019_51486_64220.jpg

Carsonite sign on LS shoulder with view of gas well in background.

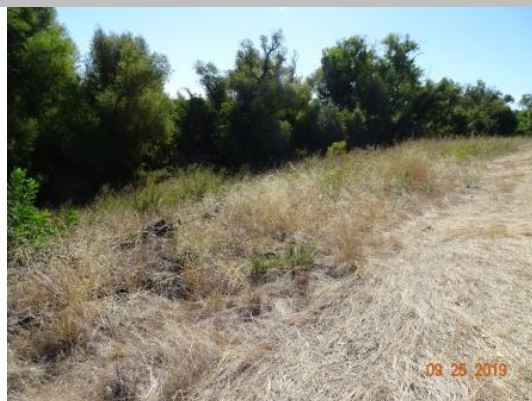
Photo 1 of 1 : FA_2019_ST0009_286_19_20190926_00023.jpg

View of the vegetation along the waterside slope. Fall 2019.

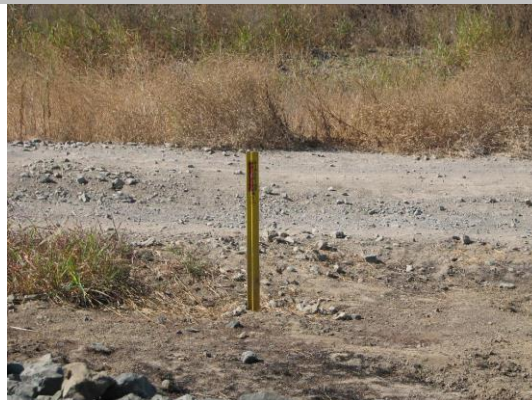
Photo 1 of 3 : UCIP_FA_2019_51487_64235.jpg

| DS_ID:16855 FS_ID:51487 EP_NO: 14455 Repair Type: Non-Urgent Crossing Status: Indicator Found UCIP Comments: 4/10/2017 LS marker still broken and there is no marker on the WS. (DWR Sutter Yard- AFreitag)10/11/2016 LS carsonite marker is still broken.(DWR Sutter Yard - afreitag)4/18/2016 Carsonite marker on LS slope is broke off.5/7/2015 Crossing is in good condition. No noticeable issues to report.11/13/2014 Same as last inspection.5/12/2014 Same as last inspection.10/30/2013 Same as last inspection.5/20/2013 Same as last inspection. FIELD_STRUCT_DESC: 1 of 2: 4.5-inch steel natural gas pipeline through the levee, 2 feet below the crown. Line goes across the Sutter Bypass and through both levees. Carsonite sign on the landside (LS) slope. Drawings are available. (Permit No. 14455, 1986 - Depco Inc.). [Additional Reference(s): DWR Levee Log, 1993]. FS Date: 4/12/2017 9:22:54 AM | | | | | |

Carsonite sign on LS slope.

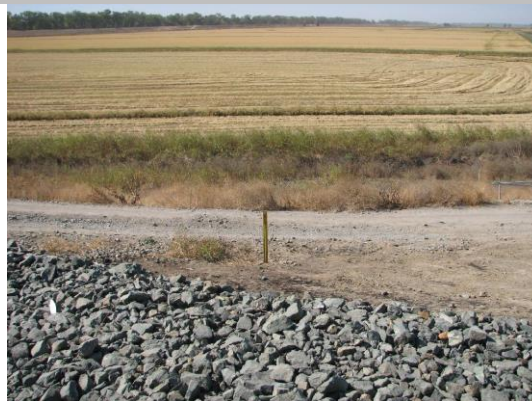
Photo 2 of 3 : UCIP_FA_2019_51487_64234.jpg

Carsonite sign on LS slope.

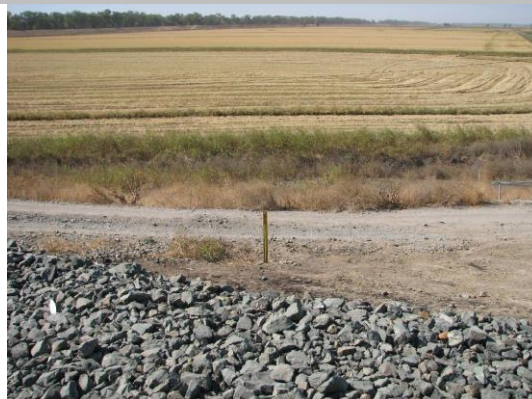
Photo 2 of 3 : UCIP_FA_2019_51488_64232.jpg

Carsonite sign on LS slope.

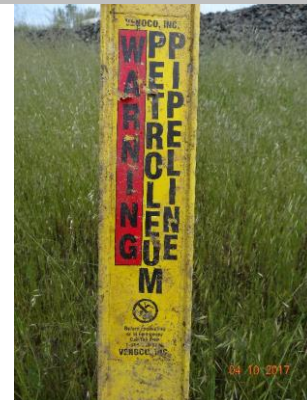
Photo 3 of 3 : UCIP_FA_2019_51488_76943.jpg

| DS_ID:16589 FS_ID:51488 EP_NO: 14455 Repair Type: Non-Urgent Crossing Status: Indicator Found UCIP Comments: 4/10/2017 LS marker still broken and there is no marker on the WS. (DWR Sutter Yard- AFreitag)10/11/2016 Carsonite marker on the LS is still broken.(DWR Sutter Yard - afreitag)4/18/2016 Carsonite marker on LS slope is broken off.5/7/2015 Crossing is in good condition. No noticeable issues to report.11/13/2014 Same as last inspection.5/12/2014 Same as last inspection.10/30/2013 Same as last inspection.5/20/2013 Same as last inspection. FIELD_STRUCT_DESC: 2 of 2: 4.5-inch steel natural gas pipeline through the levee, 2 feet below the crown. Line goes across the Sutter Bypass and through both levees. Carsonite sign located on the landside (LS) slope. (Permit No. 14455, 1986 - Depco Inc.). [Additional Reference(s): DWR Levee Log, 1993]. FS Date: 4/12/2017 9:24:35 AM | | | | | | |

Close up of LS marker

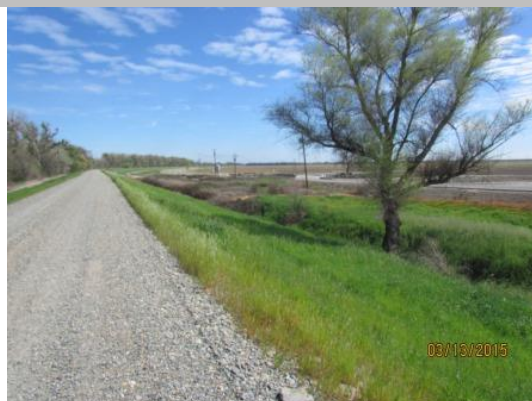
Photo 1 of 1 : FA_2019_ST0009_287_1_20190822_00001.jpg

View of the agricultural ditch along the landside toe.

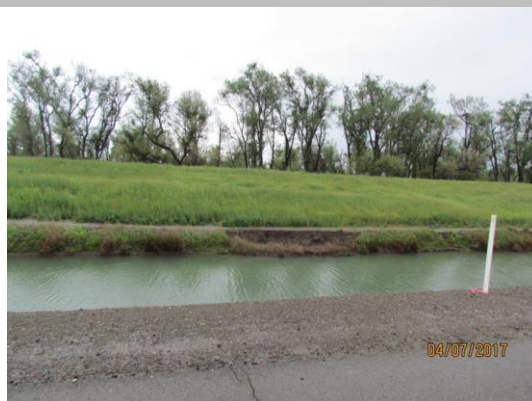
Photo 1 of 1 : FA_2019_ST0009_287_9_20190822_00006.jpg

View of the erosion along the landside toe from the County Road.

| E2 : Schedule repair of erosion site prior to the next inspection. | | | | | |

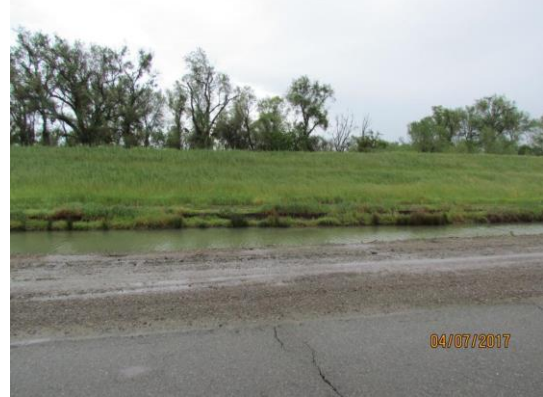
Photo 1 of 1 : FA_2019_ST0009_287_10_20190822_00007.jpg

View of the erosion along the landside toe from the County Road.

| E2 : Schedule repair of erosion site prior to the next inspection. | | | | | |

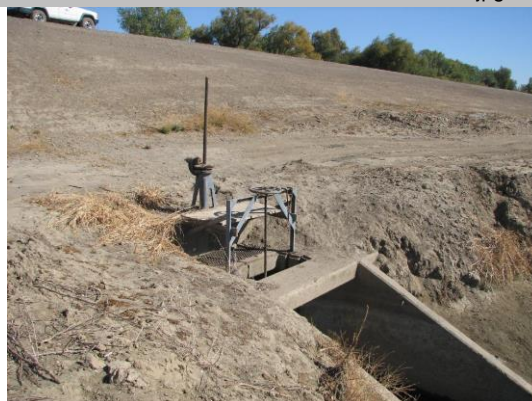
Photo 1 of 3 : UCIP_FA_2019_53047_64675.jpg

| DS_ID:16594 FS_ID:53047 EP_NO: 267 Repair Type: Urgent Crossing Status: Found UCIP Comments: 10/4/2018 Erosion around WS vault is progressing. Recommended FSRP evaluation of this site. Dense vegetation around the site. Crossing remains "Urgent" due to the erosion observed on WS. (O.Yakimov - DWR UCIP)4/10/2017 Erosion appears to be getting worse at the WS vault. It is starting to erode away the WS toe road. (DWR Sutter Yard- AFreitag)10/11/2016 Erosion still present behind the WS vault.(DWR Sutter Yard - afreitag)4/18/2016 Erosion happening around the WS concrete vault.5/7/2015 Burrowing near WS toe stil present.11/13/2014 Same as last inspection.5/12/2014 Same as last inspection.10/30/2013 Same as last inspection.5/20/2013 Same as last inspection.10/17/2012 Burrowing along downstream side of concrete vault on WS Toe. May need to be grouted. FIELD_STRUCT_DESC: 54-inch reinforced concrete irrigation pipe through the levee, 29.5 feet below the crown. Slide gates on both the waterside (WS) and the landside (LS) ends. WS end gate in 5-foot by 6-foot concrete box. LS end gate in concrete ""U"" shaped headwall. Concrete encased steel siphon pipe under and across bypass. (Permit Nos. 267 and 290 - Sutter Basin Improvement Co. [dates unknown]). [Additional Reference(s): DWR Levee Log, 1993. USACE Sacramento O&M Manual 129, August 1955 (Station 61+25)]. FS Date: 10/4/2018 1:10:58 PM | | | | | |

Slide gate at concrete outlet on LS toe.

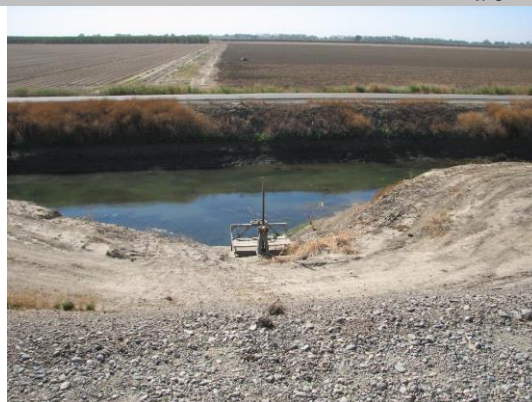
Photo 2 of 3 : UCIP_FA_2019_53047_64674.jpg

Slide gate at concrete outlet on LS toe.

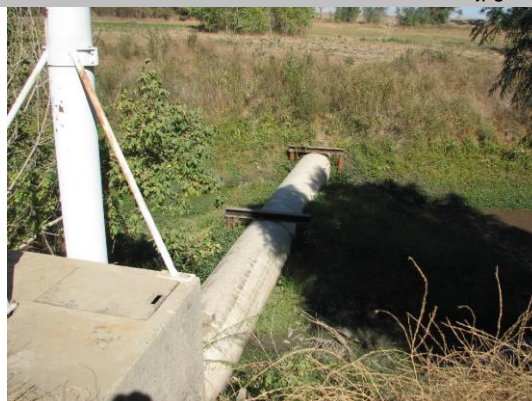
Photo 3 of 3 : UCIP_FA_2019_53047_64673.jpg

DS_ID:16594
FS_ID:53047
EP_NO: 267
Repair Type: Urgent
Crossing Status: Found
UCIP Comments: 10/4/2018 Erosion around WS vault is progressing. Recommended FSRP evaluation of this site. Dense vegetation around the site. Crossing remains "Urgent" due to the erosion observed on WS. (O.Yakimov - DWR UCIP)4/10/2017 Erosion appears to be getting worse at the WS vault. It is starting to erode away the WS toe road. (DWR Sutter Yard- AFreitag)10/11/2016 Erosion still present behind the WS vault.(DWR Sutter Yard - afreitag)4/18/2016 Erosion happening around the WS concrete vault.5/7/2015 Burrowing near WS toe stil present.11/13/2014 Same as last inspection.5/12/2014 Same as last inspection.10/30/2013 Same as last inspection.5/20/2013 Same as last inspection.10/17/2012 Burrowing along downstream side of concrete vault on WS Toe. May need to be grouted.
FIELD_STRUCT_DESC: 54-inch reinforced concrete irrigation pipe through the levee, 29.5 feet below the crown. Slide gates on both the waterside (WS) and the landside (LS) ends. WS end gate in 5-foot by 6-foot concrete box. LS end gate in concrete "U" shaped headwall. Concrete encased steel siphon pipe under and across bypass. (Permit Nos. 267 and 290 - Sutter Basin Improvement Co. [dates unknown]). [Additional Reference(s): DWR Levee Log, 1993. USACE Sacramento O&M Manual 129, August 1955 (Station 61+25)].

Concrete box, vent, and 54-inch steel pipe in WS toe.

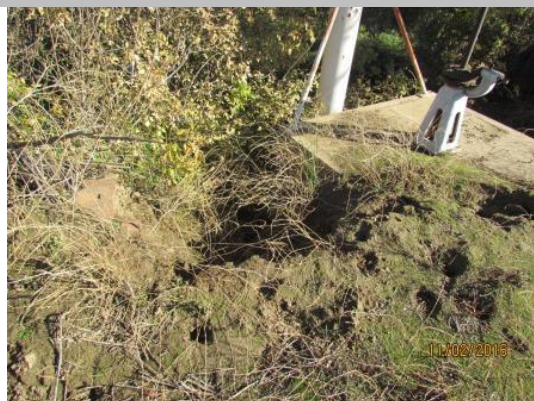
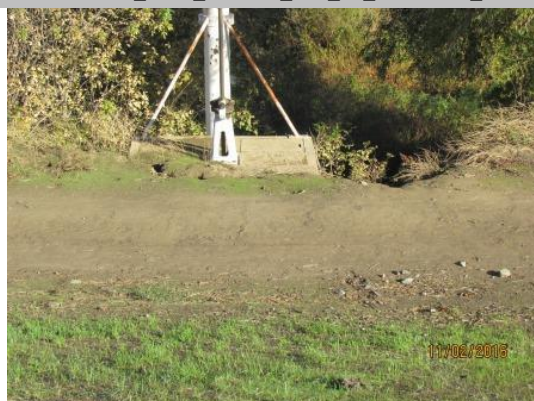
Photo 1 of 2 : FA_2019_ST0009_287_13_20190822_00009.jpg

| Erosion around the WS concrete vault. | | | | | |

View of the erosion along the concrete vault.

Another view of the erosion along the concrete vault.

| E2 : Schedule repair of erosion site prior to the next inspection. | | | | | |

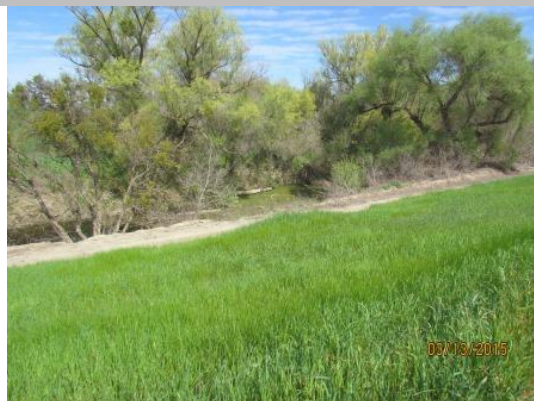
Photo 1 of 1 : FA_2019_ST0009_287_290_20190822_00012.jpg

View of the erosion along the waterside berm.

| Sutter Yard needs to monitor the erosion along the berm. | | | | | |

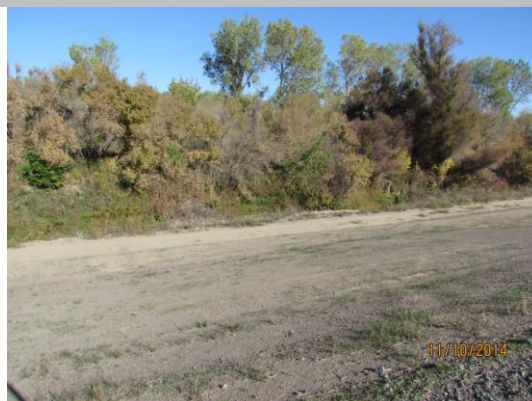
Photo 1 of 1 : FA_2019_ST0009_287_4_20190822_00003.jpg

View of the erosion along the waterside berm.

| E2 : Schedule repair of erosion site prior to the next inspection. | | | | | |
| Sutter Yard needs to monitor the erosion. | | | | | |

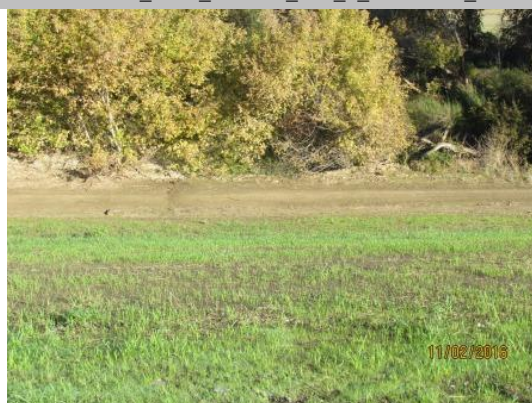
Photo 1 of 1 : FA_2019_ST0009_287_5_20190822_00004.jpg

View of the erosion along the waterside berm.

| E2 : Schedule repair of erosion site prior to the next inspection. | | | | | |
| Sutter Yard needs to monitor the erosion. | | | | | |

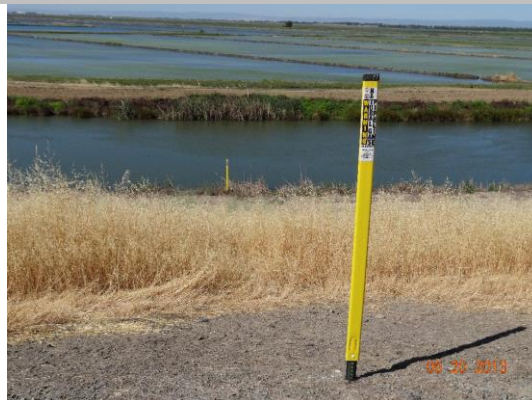
Photo 1 of 3 : UCIP_FA_2019_51491_64681.jpg

DS_ID:23099
FS_ID:51491
EP_NO: N/A
Repair Type: Non-Urgent
Crossing Status: Found
UCIP Comments: 4/10/2017 Crossing appears to be in good condition.
(DWR Sutter Yard- AFreitag)10/11/2016 Crossing appears to be in good condition but there is no permit on file. Photos of the markers were uploaded on 5/20/2013.(DWR Sutter Yard - afreitag)5/3/2016 Need photos of markers on both WS and LS. 4/18/2016 Crossing appears to be in good condition. No noticeable issues to report.5/7/2015 Crossing is in good condition. No noticeable issues to report.11/13/2014 Same as last inspection.5/12/2014 Same as last inspection.10/30/2013 Same as last inspection.10/17/2012 Need to identify permit for crossing.
FIELD_STRUCT_DESC: Steel natural gas pipeline of an unknown size through the levee, at an unknown depth. Markers visible on the landside (LS) shoulder and toe and the waterside (WS) shoulder and toe. No permit has been identified since the crossing was field discovered in 2012.

Marker on LS shoulder and toe

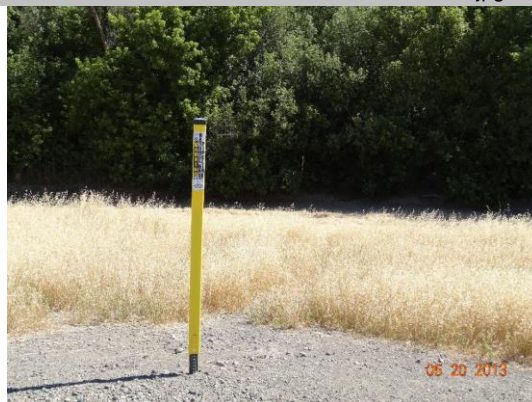
Photo 2 of 3 : UCIP_FA_2019_51491_64680.jpg

Marker on WS shoulder

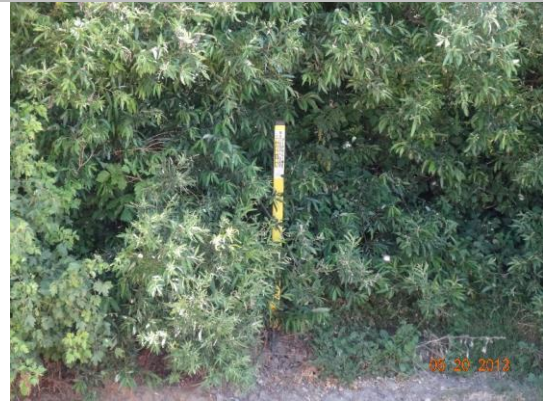
Photo 3 of 3 : UCIP_FA_2019_51491_64679.jpg

| DS_ID:23099 FS_ID:51491 EP_NO: N/A Repair Type: Non-Urgent Crossing Status: Found UCIP Comments: 4/10/2017 Crossing appears to be in good condition. (DWR Sutter Yard- AFreitag)10/11/2016 Crossing appears to be in good condition but there is no permit on file. Photos of the markers were uploaded on 5/20/2013.(DWR Sutter Yard - afreitag)5/3/2016 Need photos of markers on both WS and LS. 4/18/2016 Crossing appears to be in good condition. No noticeable issues to report.5/7/2015 Crossing is in good condition. No noticeable issues to report.11/13/2014 Same as last inspection.5/12/2014 Same as last inspection.10/30/2013 Same as last inspection.10/17/2012 Need to identify permit for crossing. FIELD_STRUCT_DESC: Steel natural gas pipeline of an unknown size through the levee, at an unknown depth. Markers visible on the landside (LS) shoulder and toe and the waterside (WS) shoulder and toe. No permit has been identified since the crossing was field discovered in 2012. FS Date: 4/12/2017 9:30:05 AM | | | | | | |

Marker on WS toe
